Young worker injured when excavation wall collapses

Notice of Incident information

Number: 2007157410184

Core activity: Installing drain pipe in trench

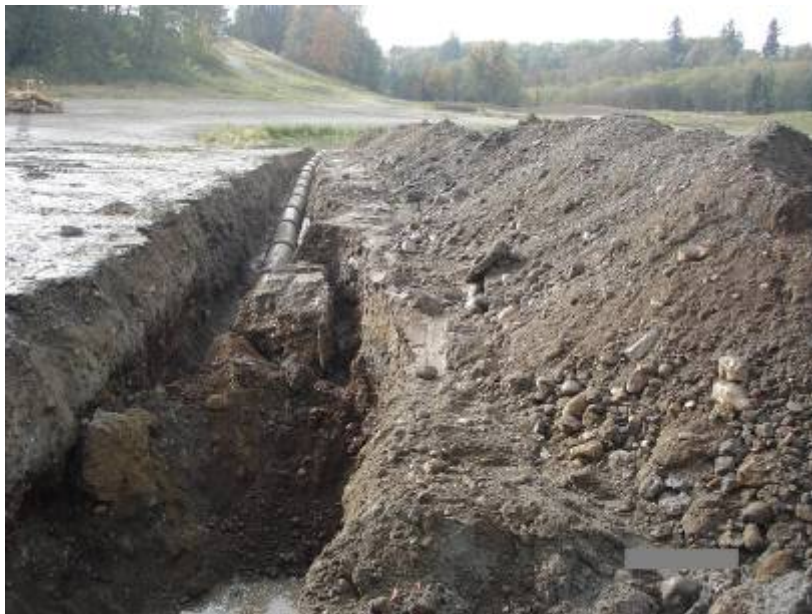
A young worker was standing on a section of pipe in an unsloped, unshored trench about 6.5 feet deep. He was waiting for another worker to deliver a new section of pipe by excavator. The worker's supervisor noticed water at the bottom of the trench, about 6 to 8 feet from the worker, and told him to get out. The worker stepped off the pipe into the trench to retrieve a laser stick before exiting the trench. At that moment, part of the trench wall collapsed, burying the worker almost up to his chest and causing serious injuries.

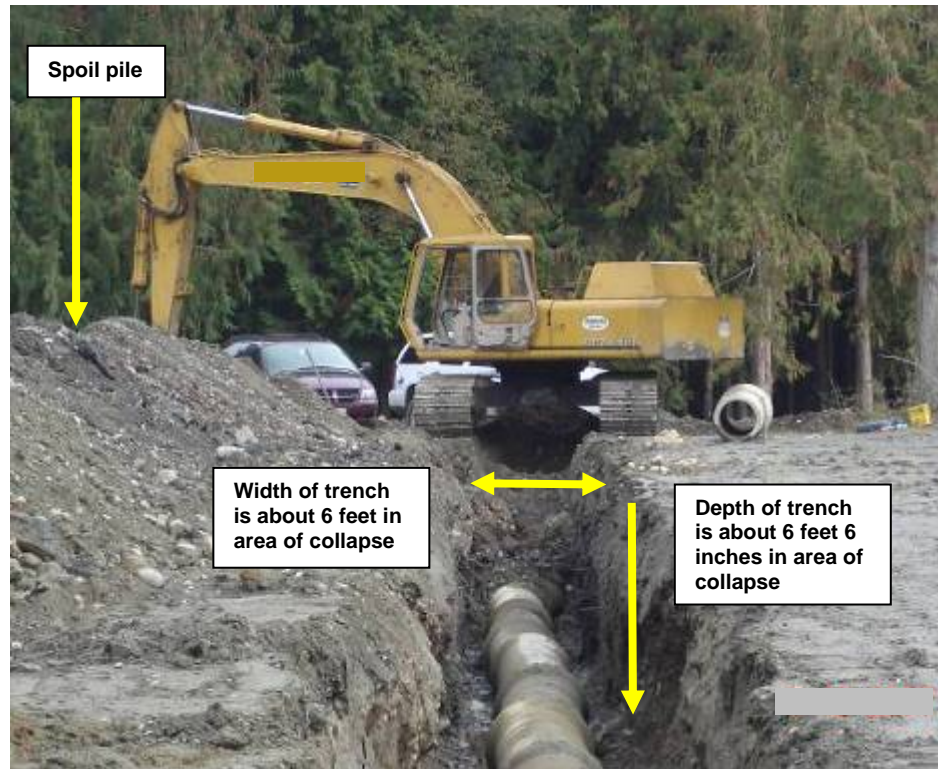
Figure 1: The excavator used to dig the trench.

Machinery working next to an excavation can cause excessive vibration in the ground, which in turn causes the ground to shift. The Owner was using an excavator to dig the trench and another one to deliver pipe to the trench. The weight of these two machines and their vibration could have contributed to the ground shifting.

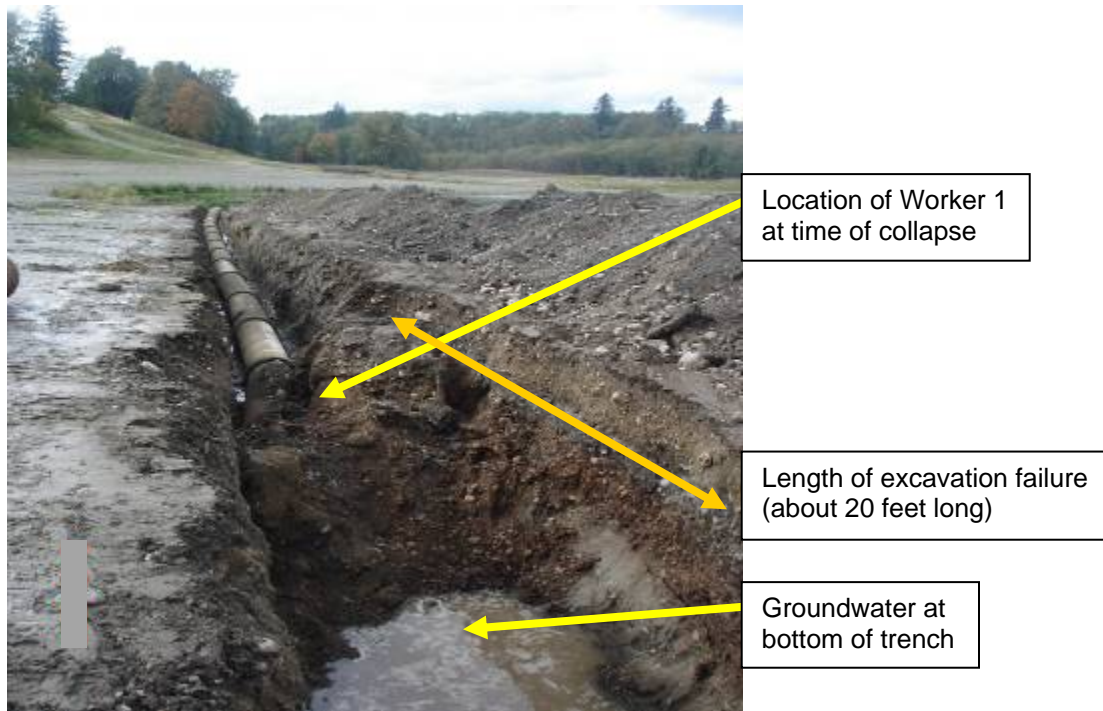
Figure 4: *The trench.*

The failure occurred about 150 feet from the pond. The collapsed embankment was about 20 feet long (see Figure 4). Undermining and sloughing of trench walls began at the 14-foot mark from the start of the trench, and at 30 feet even more sloughing was evident. The area where the incident occurred — that is, the area where Worker 1 was standing on top of the 20-inch-diameter pipe — was one of the deeper sections of the trench (6 feet, 6 inches).

Photographs taken on the day of the incident show groundwater at the bottom of the trench, beneath the pipe. Some undermining and sloughing in the trench were obvious. The spoil piles, generally more than 2 feet deep, were close to the edge on the north side of the trench. In the area of the failure, the spoil pile was 5 feet away from the unsupported edge of the trench. There was no engineering input for the excavation work, and the trench was not excavated according to any plan or specification. The trench walls were not adequately sloped nor was any shoring used.

The excavation was unsupported, and the resulting increase in lateral soil pressure was not taken into account. In addition, the depth of the spoil piles exceeded 2 feet on the north side of the trench. The location of spoil piles next to the trench increased both the vertical and the lateral pressure on the trench walls. This pressure forced soil out of the sides of the unsupported embankment, causing a cave-in.
