Young worker injured when excavation wall collapses

Notice of Incident information

Number: 2007157410184

Core activity: Installing drain pipe in trench

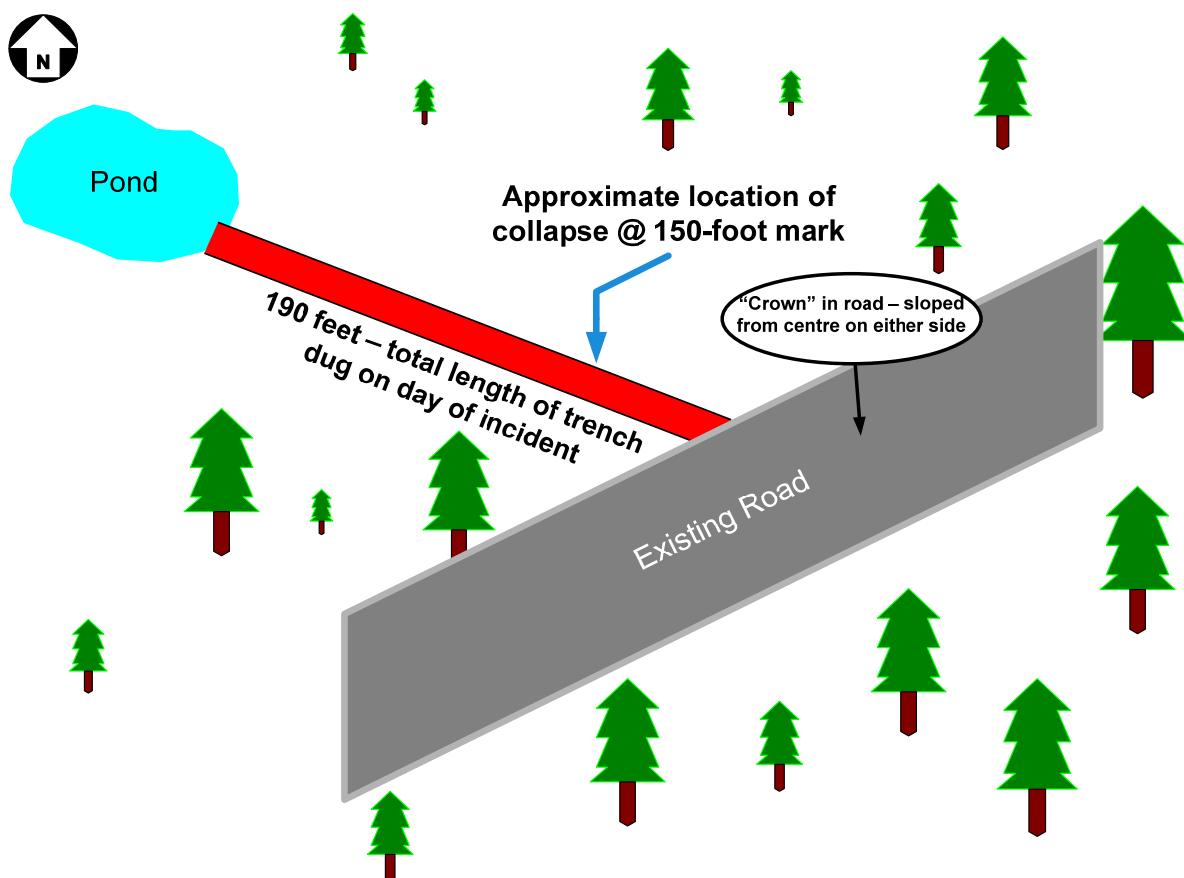
Figure 3: Site layout.

The trench was to be 280 feet long and 5 to 6 feet wide. The excavation started at the pond at the west end and moved in an easterly direction (see Figure 3). For much of its length the trench followed an existing road. By the time of the incident, 190 feet had been dug. At the west end, the trench was 2 feet deep, although most of it was 3 to 4 feet deep. However, the excavation reached a depth of about 7 feet where it joined the existing road, sloping down on either side of the road's high point or "crown."

The edges of the trench were cut back somewhat. The spoil pile, over 2 feet high, was dumped on the north side of the trench, 3 to 5 feet away from its sides.
